Company: Disa S.A., Chile

Description: LG Sonic unit for irrigation basin in Chile.

Project objective: Reduce algae mats and improve water quality in irrigation reservoir.

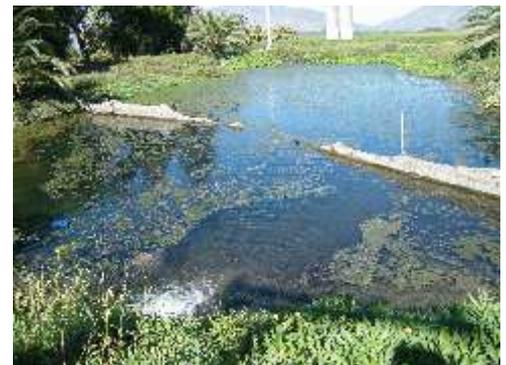
Figure 1: Day 1 of treatment. The algae mats are dispersed, light green colour and cover the entire reservoir.

Agro business companies need to maintain water supplies of sufficient quantity and quality to have profitable yields. This water is usually affected by cattle grazing and highly nutrient run off that cause eutrophication. Algal populations can become large enough to clog irrigation systems and control often becomes necessary. Typical algae control methods (chemical and physical) are labor intensive and may even involve safety issues. One of the main water reservoirs of the company Disa S.A in Chile, peach and grape grower, was suffering from severe algae growth in their reservoir. The surface was covered with dark green filamentous algae mats that covered the entire surface, and caused problems in the pumps and nozzles used to irrigate crops and nurseries.

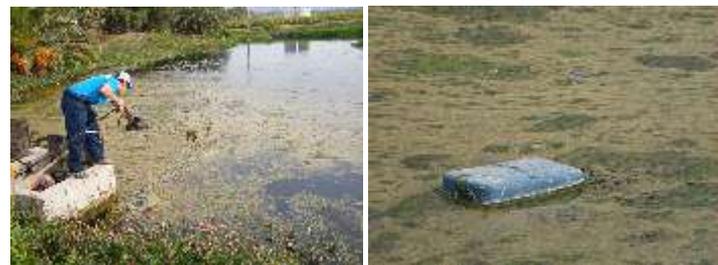
Figure 2: Day 45 of treatment. Algae mats are concentrated and turn brownish, which means that they are dying.

The company took pictures during the treatment to monitor the effects of LG Sonic technology on the algae mats. After 45 days, half of the water surface was clear and the rest was covered with a brownish layer of algae. The majority of the algae covering the surface turned progressively from dark green to bright green to finally brown-yellowish. This change in colour indicates that algae are irreversibly dying. To accelerate the improvements, it was recommended to harvest mechanically the dead algae.

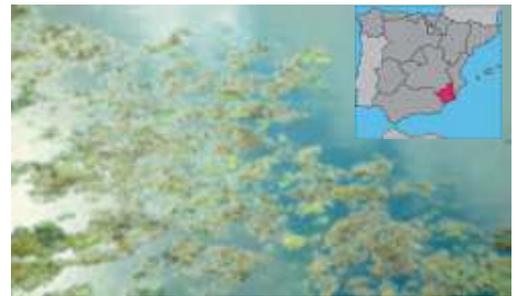
Figure 1: View of the algae mats before LG Sonic treatment and geographical location of the reservoir.

Covering up the water reservoir does not always solve the problem. Covering the reservoir to avoid sunlight may increase water temperatures underneath which can lead to uncontrolled growth of bacteria and other micro-organisms. Chemical treatment may damage the crops and farmland and have safety issues. Aeration, where oxygen is added to the water, alone does not suffice either. Pumps and nozzles were continuously clogged in a water reservoir owned by an important fruit producer in Murcia province, in Southeastern Spain.

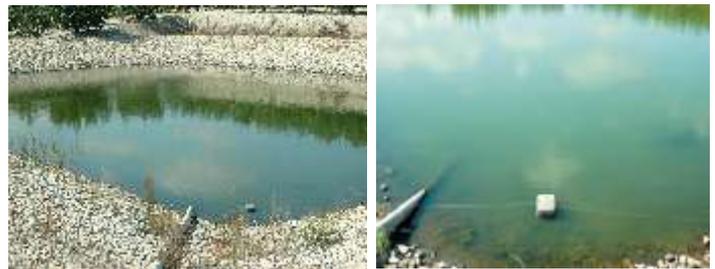
Figure 2: Views of the water quality one month after the installation of the LG Sonic unit. Absence of algae

The concentrations of chlorophyll a and total were monitored. These two parameters help to estimate the concentration of phytoplankton (microscopic algae) before and after LG Sonic treatment. When treated with the LG Sonic equipment, the water quality showed great improvement as shown on the table below. Other important physico-chemical parameters have not been monitored but it is recommended to keep an eye on suspended and dissolved solids, magnesium, Iron (2) and H₂S that can influence the formation of obstructions in tubes and pipe systems.

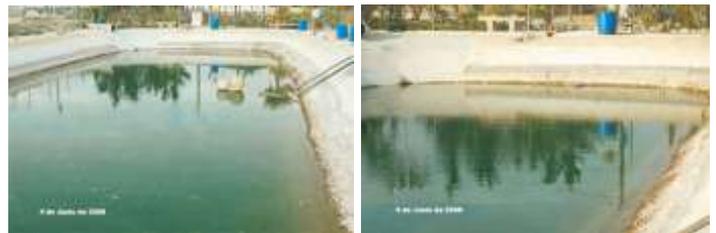
Figure 1: Day 1 of treatment. The algae mats are dispersed all over the reservoir and the water is turbid.

Agro business companies need to maintain water supplies of good quality to avoid water borne diseases that could affect their cattle. Moreover algal concentration can become a severe issue if toxins are released into the water and livestock drink from it. One of the main water reservoirs of the cooperative Ampelax, in Murcia presented dispersed floating algae that partially covered the water surface. The cooperative was seeking a solution to improve the water quality in the reservoir

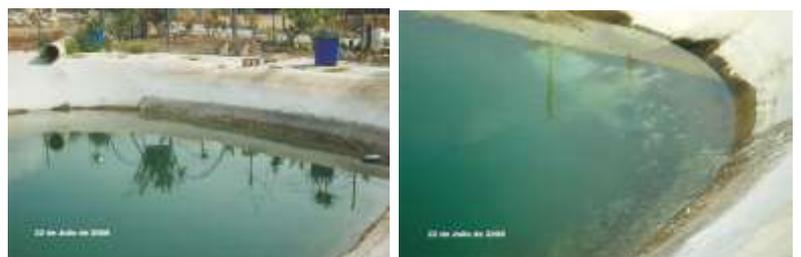
Figure 2: Day 49 of treatment. Algae disappeared and turbidity was improved.

After finalizing the test, it was observed a strong reduction in algae and aerobic bacteria concentration. This lower amount in micro-organism concentration lowers the organic pollution, biochemical oxygen demand (BOD). This subsequently helps improving the quality of the drinking water. This allows longer water storage time and reduction of the decomposition rate.
