Biofouling Prevention Cases

The LG Sonic Industrial Line has been successfully installed in a wide range of applications, such as cooling towers, clarifiers and treatment plants

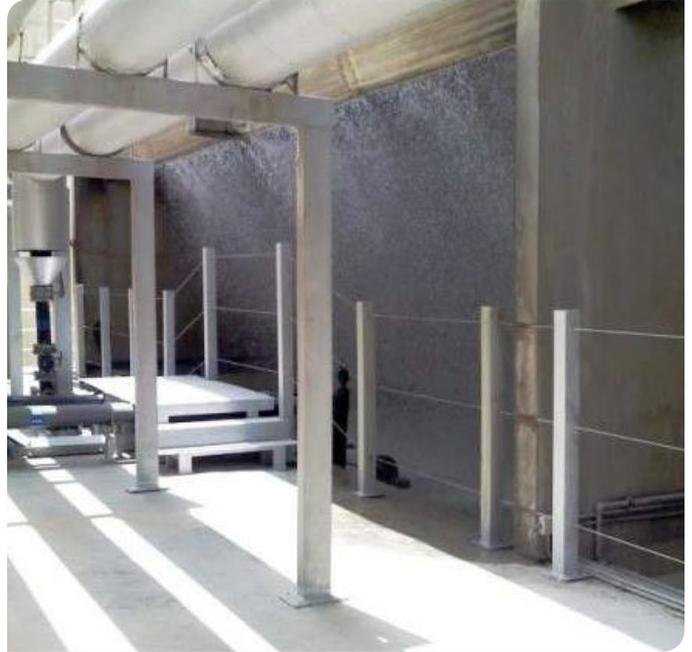
Al Futtaim Cooling district plant in Dubai incorporated the LG Sonic technology into their chemical treatment program to reduce the biocide consumption in the cooling towers and improve the water quality.

- ✔ Up to 69 % reduction in biocide dosage
- ✔ Up to 53% reduction in anti-scalant dosage
- ✔ Microbial analysis of the water after tests of satisfactory quality and within specific limits

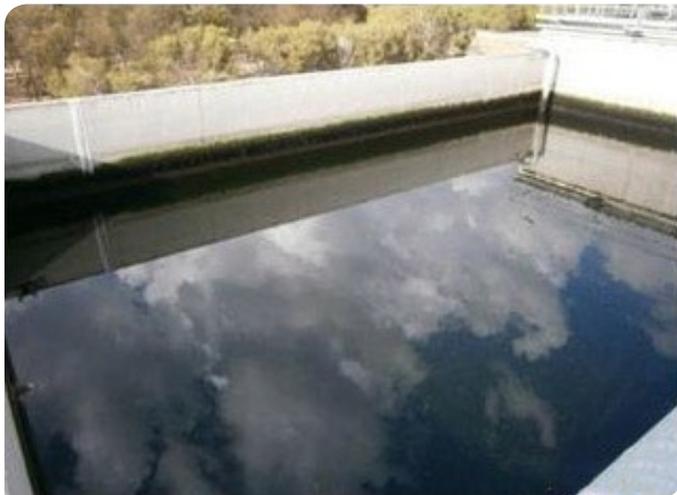
Several LG Sonic devices were installed in a Wastewater Treatment Plant (WWTPs) in Melbourne, Australia to prevent biofouling. High algae concentrations created problems for process performance and increased operating expenditure for cleaning and maintenance activities.

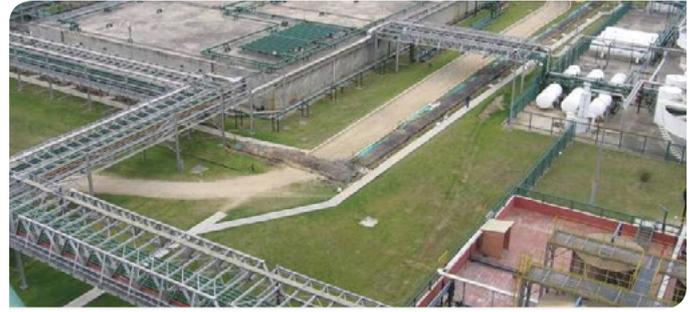
Several LG Sonic devices were installed in the SAB Miller Clarifier in Tocancipa Brewery, Colombia to control filamentous algae caused by biofouling. The algae attached to the biofilm was identified as suspended and was growing on walls and water channels of the clarifiers, reducing process efficiency and increasing the cleaning efforts of the plant

Extensive testing showed the LG Sonic devices had a significant impact on the filamentous algae and bio-corrosion. Workers at the brewery didn't need to dose hydrochloric acid during maintenance, which resulted in less time required for the maintenance and substantial improvement of safety conditions for workers.

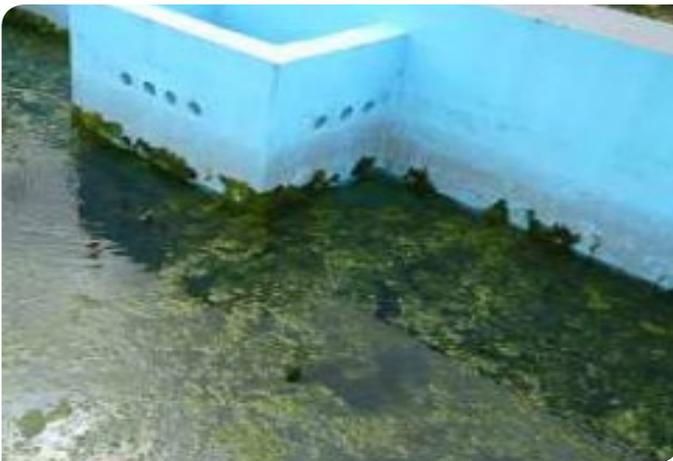
Figure 1: Before treatment

A potable water treatment plant in Kuse (Japan) installed several LG Sonic systems in the sand filters to prevent the formation of biofouling. Filamentous algae grew abundant in the sand filters, creating problems with the taste of the water and clogging of the filters.

After several weeks of treatment, it was visible that the number of filamentous algae has decreased. The filters were not clogged due to less biofouling formation and the maintenance of the filter beds could also be reduced.
