## Waste Water Clarifier

July 2007, Shenandoah, Virginia USA.

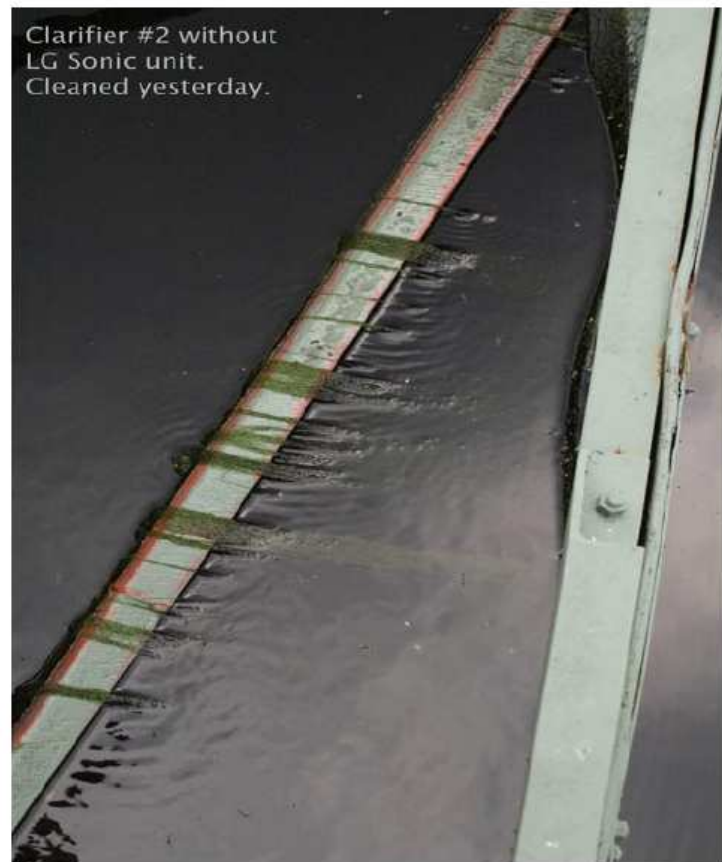
### No Ultrasound - Cleaned Yesterday

Our customer typically cleaned his 3 clarifiers each week which took 4-5 hours total. He now cleans all three clarifiers once a month. A visual notation was made that noted the improved clarity of the water inside the clarifier. The city also noticed a slight reduction in their chlorine demand before the discharge to the creek.

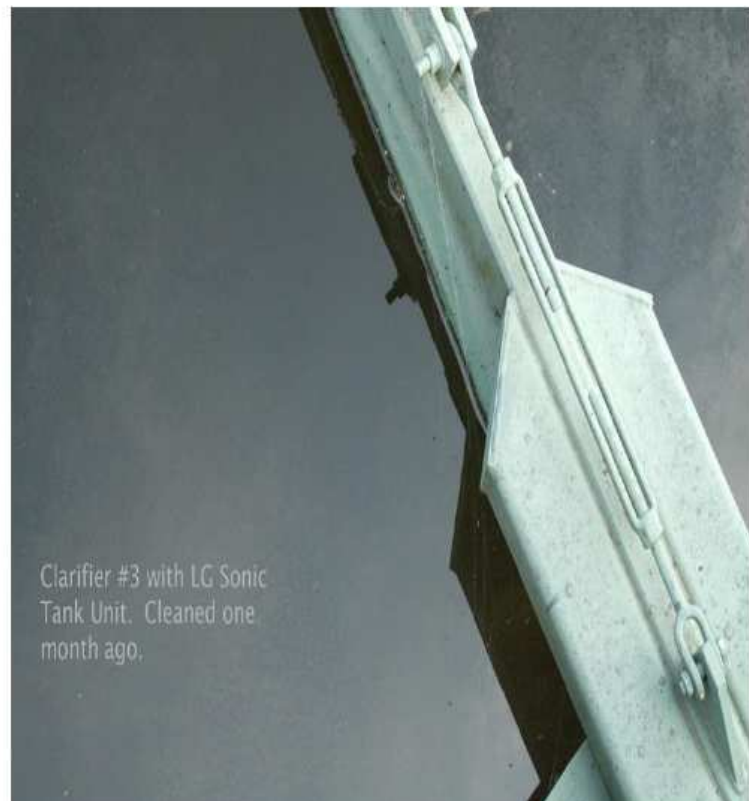
### With Ultrasound - Still Clean 30 days Later
