Bush Beans Case Study

Customer: Bush Beans

Application: Steam Boiler

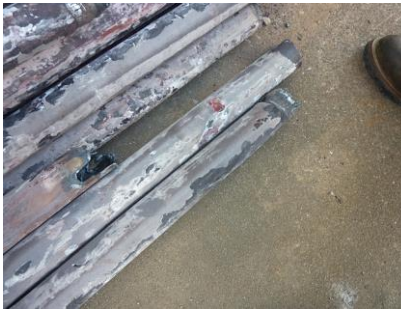
Boiler Tubes (before)

The Challenge: Bush Beans were experiencing significant scale accumulation on their fire tube steam boiler despite the use of scale inhibiting chemicals. Bush Beans adhere to a strict blow down schedule as part of their planned maintenance program.

Bush Beans had to take their boiler offline every 6 to 12 months in order to inspect and descale the water drum and tubes.

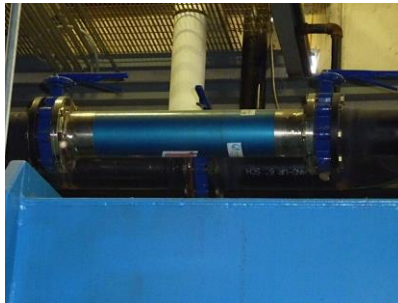
6" Colloid-A-Tron installation

The Solution: Fluid Dynamics were called in and having assessed the system recommended the installation of a 6" Colloid-A-Tron on the main feed to the boiler.

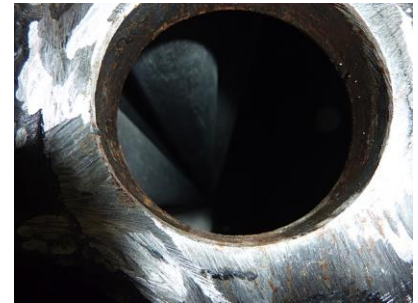
View inside the water drum (after)

Results: Following the installation, the boiler was opened up for inspection 6 months later. The reduction of scale was very apparent, any scale that was present was soft and easily washed away without the use of chemicals whereas in the past chemicals and mechanical methods (chipping hammers etc.) had to be used to remove a hard scale accumulation. Bush Beans are delighted with the reduction in maintenance and associated down time. As expected, energy costs are down due to the savings associated with operating a scale free system.
