Algae Control in Drinking Water Reservoir La Fe

Drinking water reservoir, EPM, Colombia

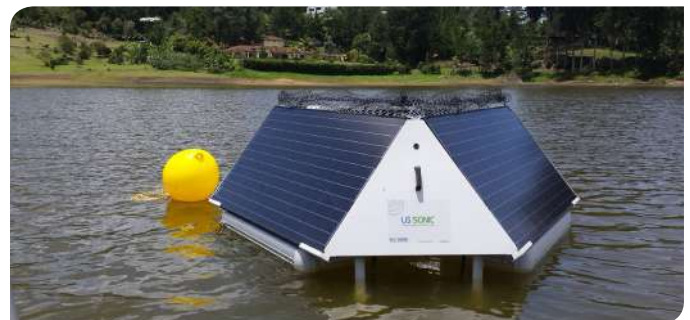
Figure 1: Close-up of the MPC-Buoy installed in La Fe reservoir

Given the scale of the project, the best technical and economic solution was to install eight ultrasonic systems spread over the entire reservoir. The MPC-Buoy system provides a complete and environmentally friendly solution to control algae in large water surface. Solar energy powers the systems and operate remotely, which results in low operational costs.
